**Re: WO-A-0088, Regak Bridge Warranty Inspection Report**

Regak Bridge is located in Shahidi Hassas district of the Uruzgan province. The bridge is constructed across the Shakur River. The Bridge is a steel truss design consisting of three spans of different lengths. The entire bridge superstructure is prefabricated and substructures are cast-in-place reinforced concrete. Photographs taken during the inspection are attached to this inspection report. The following are the findings from the bridge inspection.

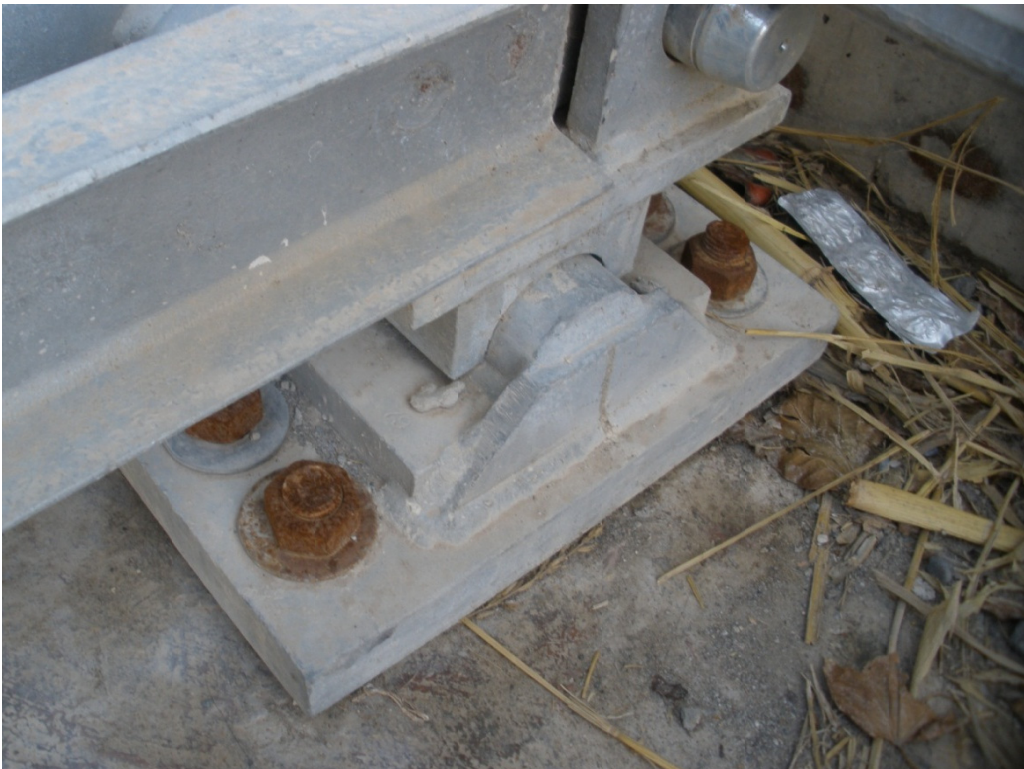
The prefabricated elements: the pins (clip, bearing, keeper angle), the bolts (for chord, long rocker, transom shear, deck T, brace) and panel members (chord, diagonal and vertical rockers, decking transom, brace, etc.) are generally in good condition. The steel members are galvanized and are still zinc covered, except for some of the bolts located at the bridge bearing plate that were observed to be oxidized. See Figure 8.

- At Station 0+440 km on the left side of the roadway and at Station 0+550 km right side slope erosion due to storm water runoff has appeared. See Figure 35.
- Some of the bolts at abutment bearing observed to be oxidized. See Figure 8.
- Roadway at Station 0+580 to 0+620 km is washed out; this area appears to have washed out due to the lack of proper drainage. There are a few minor potholes and rutting on the roadway and some oversized rock pockets on the subgrade of the road. See attached Figures 36, 37 and 38.
- The local residences excavated an irrigation ditch on the roadway at Station 0+175 km which caused some rutting in that area. See Figure 30.

**Figure 8: Bridge Bearing Plate**

The superstructures and substructures with their elements in Regak Bridge appeared to be in good condition and there were no visible signs of major deficiency. The oxidized nuts and bolts at the abutment bearing (Figure 8) need corrective measures. The roadway and the slab culvert mentioned under problem areas above will require maintenance work to be done.

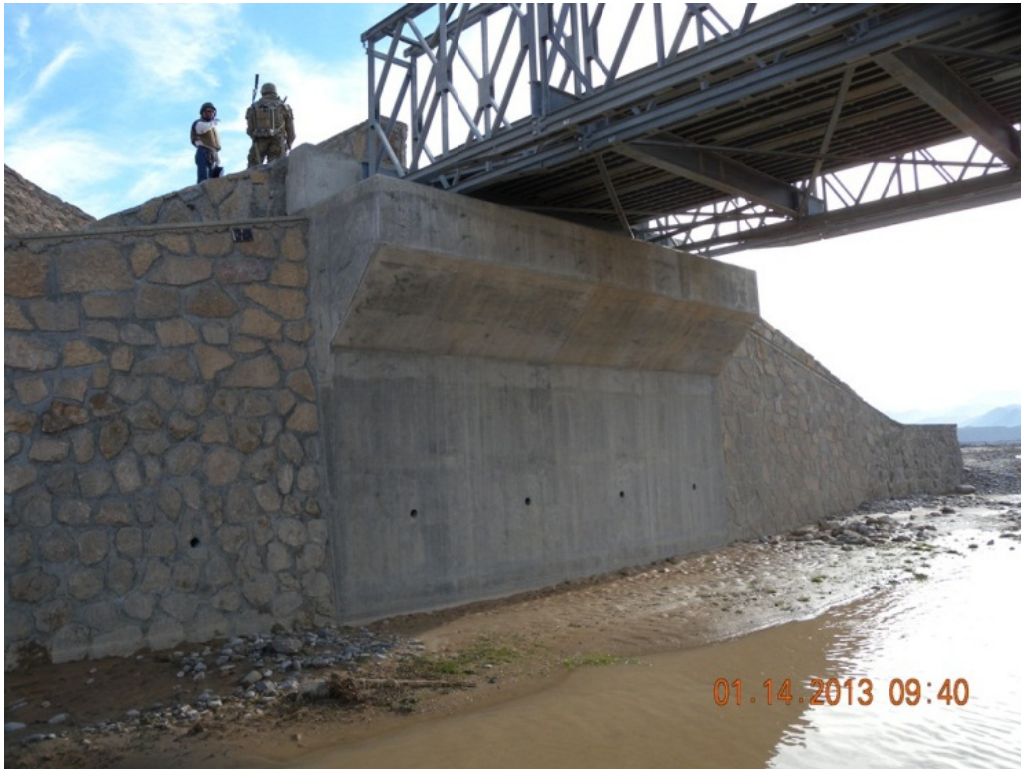
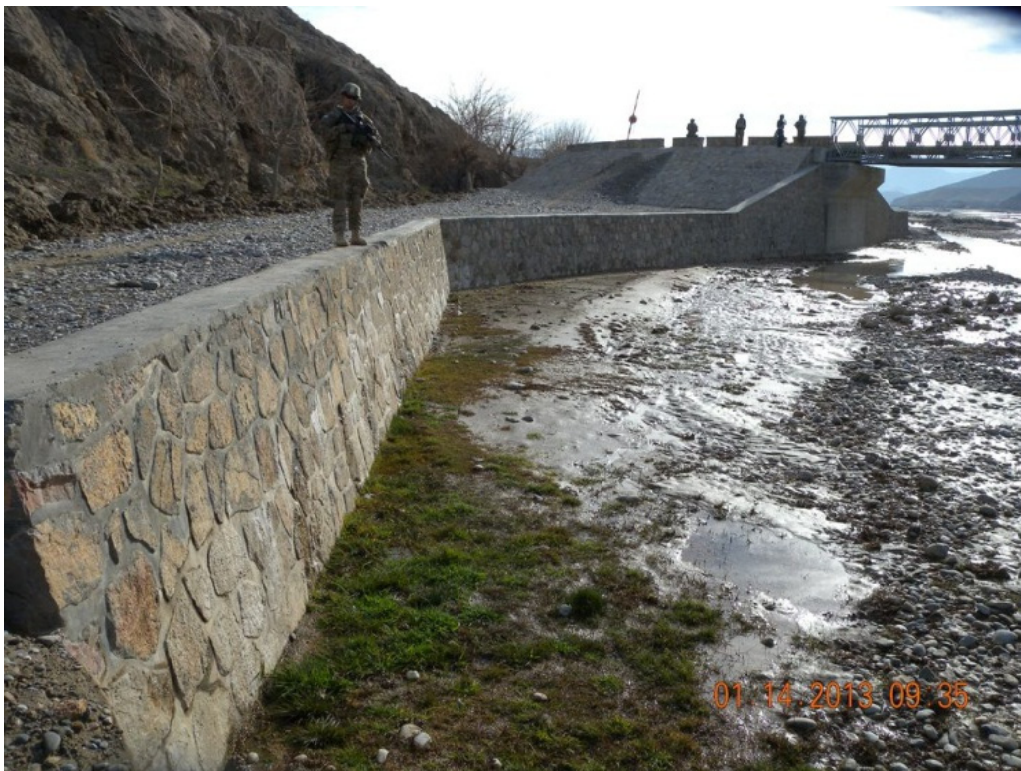
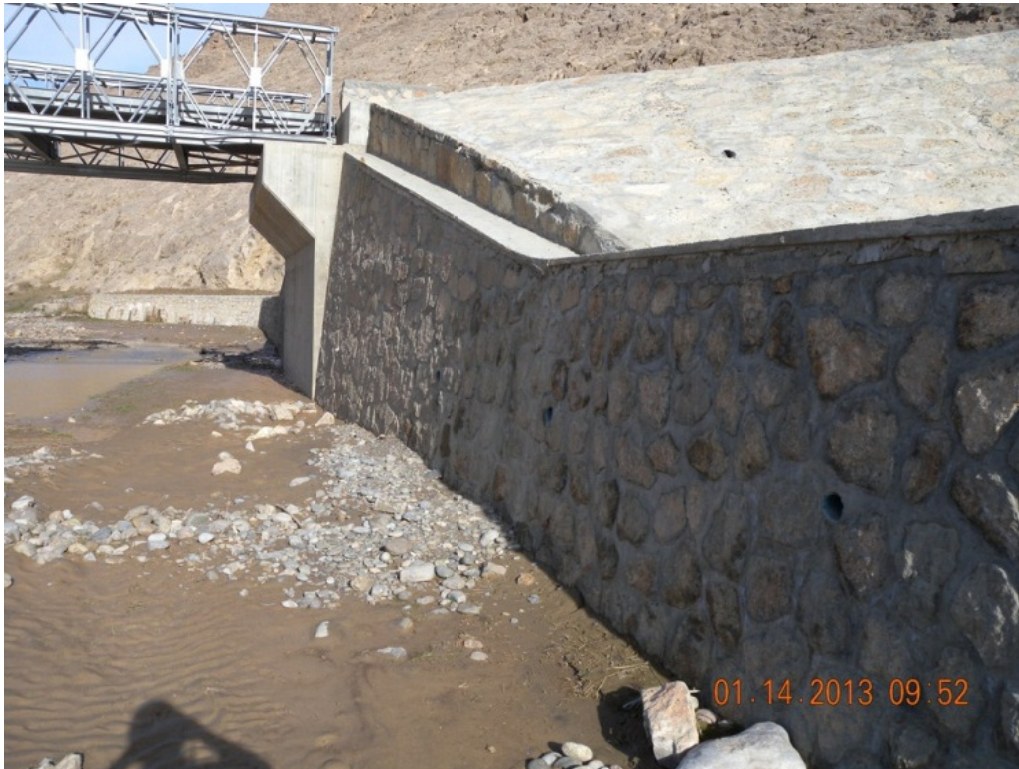
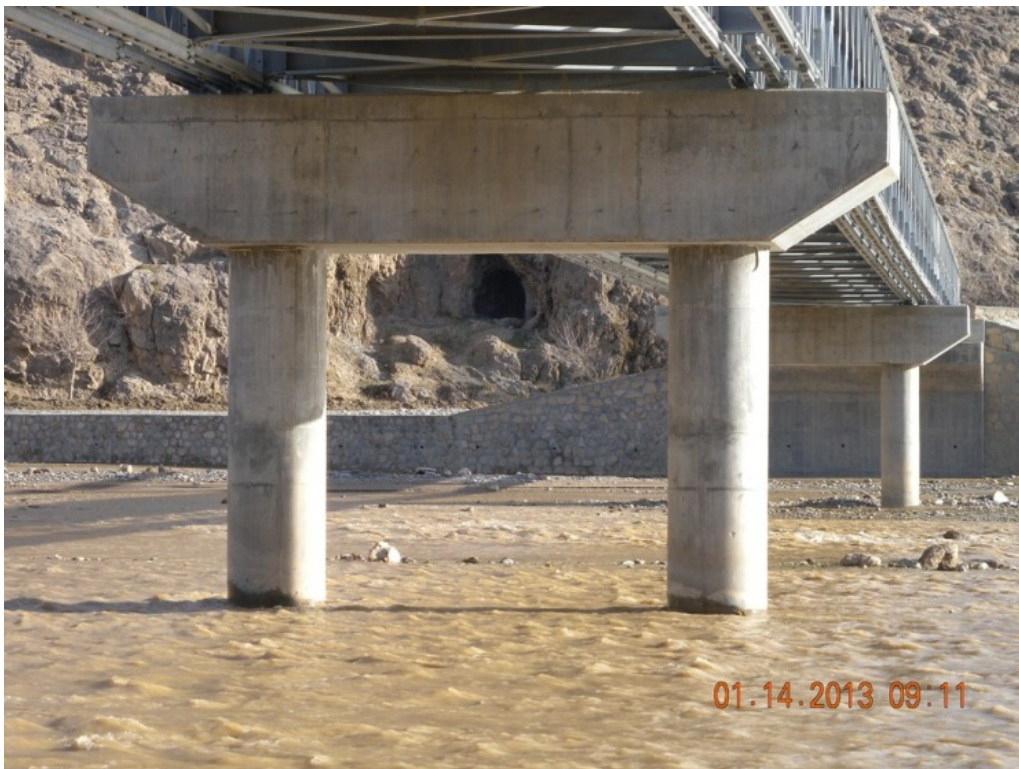
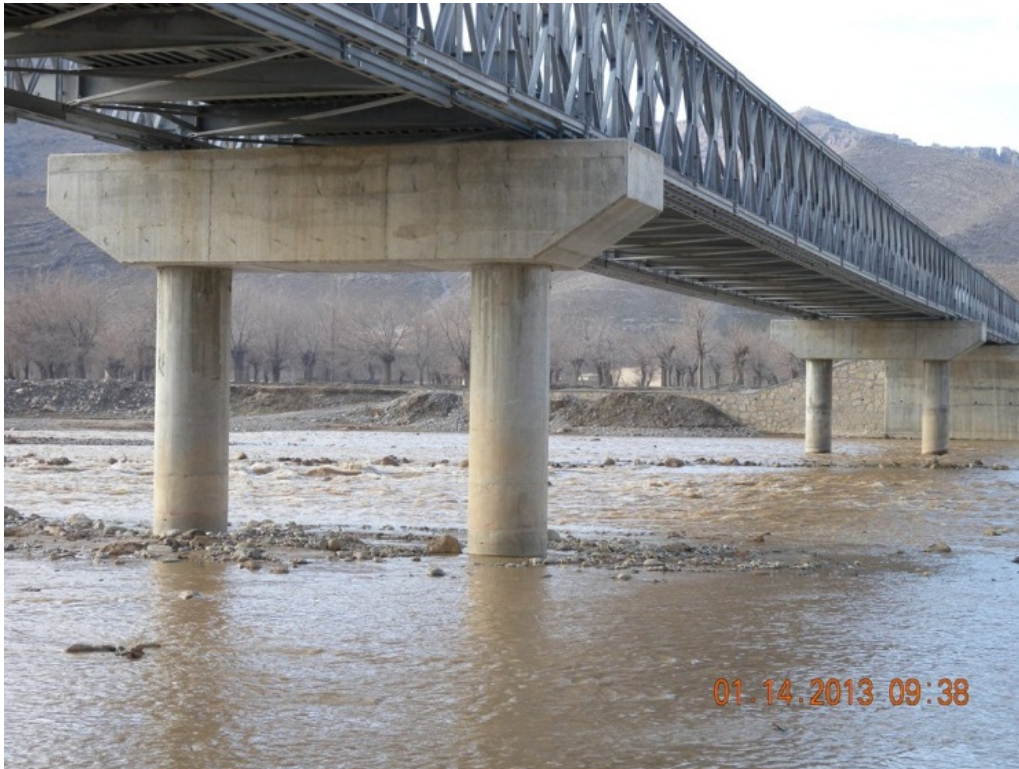
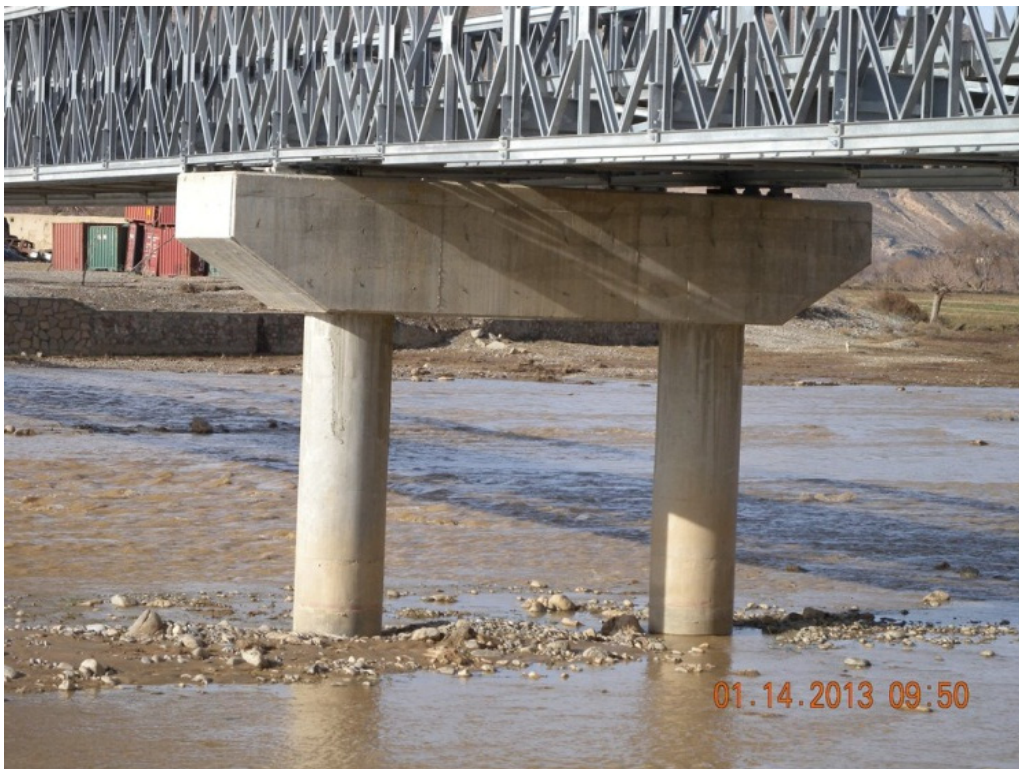
Abutment #A1 and A2 (reinforcement concrete breast wall and stone masonry wall), Pier #1 and Pier #2 (reinforcement concrete pier cap and column) are generally in good condition. The foundation of the abutment and piers were not inspected due to water in riverbed. See Figures 13 through 18.

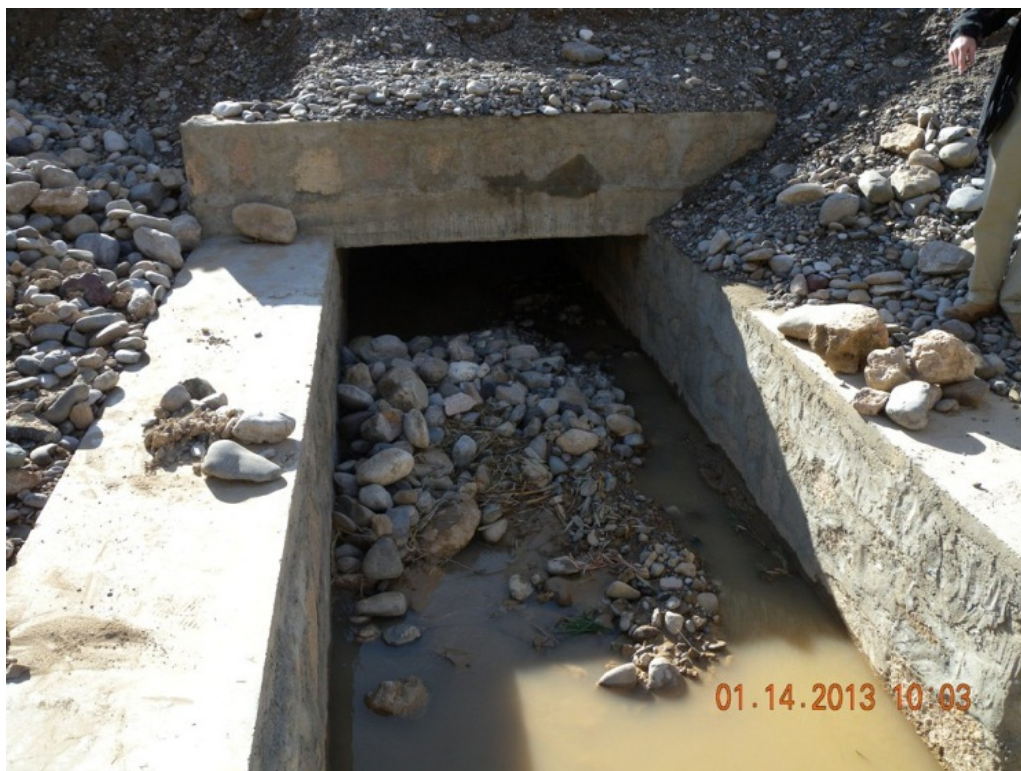
The box culvert at Station 0+542 km was constructed with stone masonry wall, plain concrete bottom slab and reinforcement concrete top slab. The culvert was in good condition but there was mud and debris at the bottom of slab on the inlet side. See attached Figure 27.

**Figure 27: View of slab culvert inlet at Station 0+542 km with debris which needs clearing**

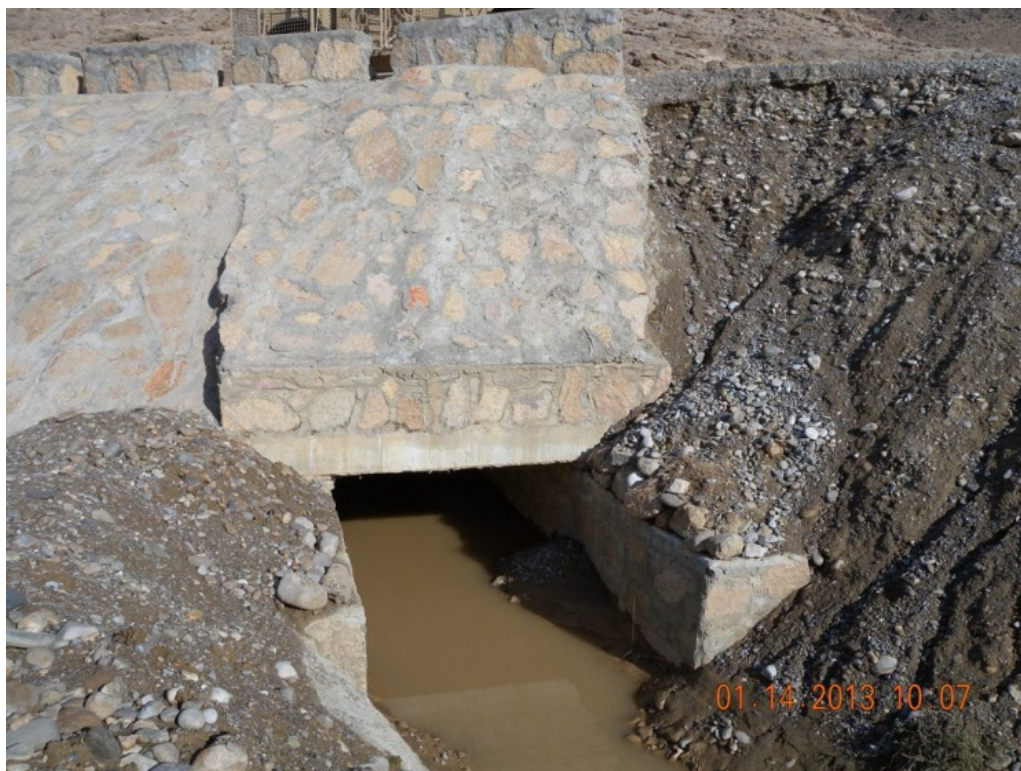
**Figure 29: View of slab culvert outlet and the end point of stone masonry slope protection in which the roadway slope is eroded by rainfall at Station 0+550 km**

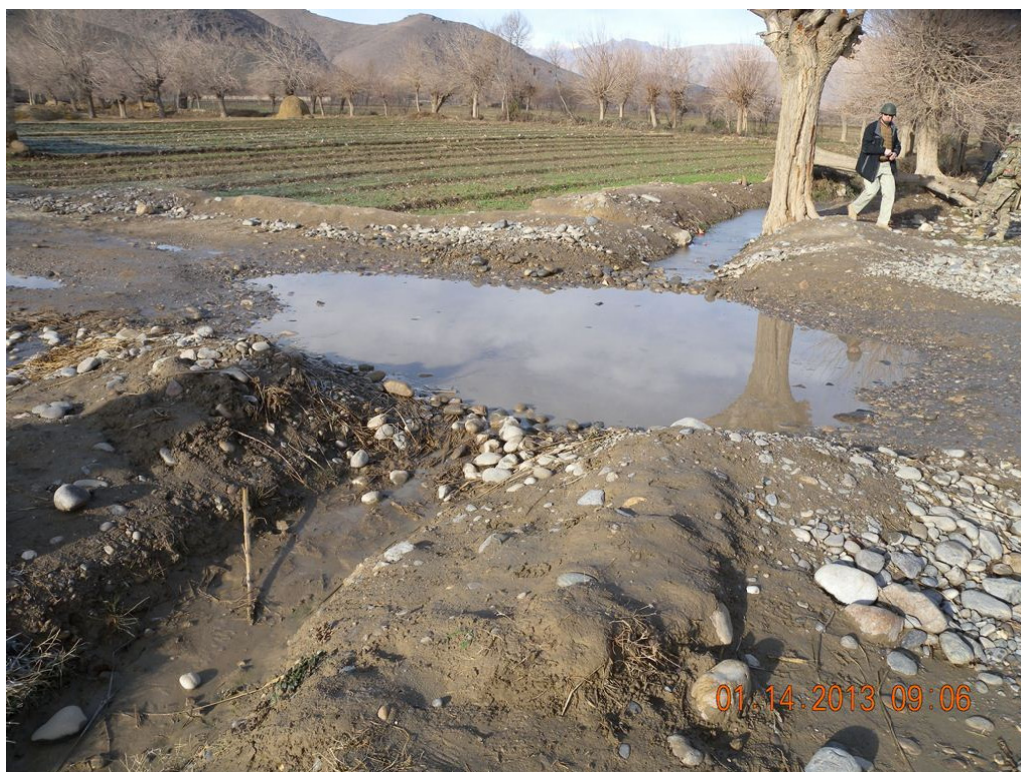
**Figure 30: View of excavated ditch across the roadway by local people for irrigation purpose at Station 0+175 km which caused some rutting in that area there is a need for a pipe culvert**

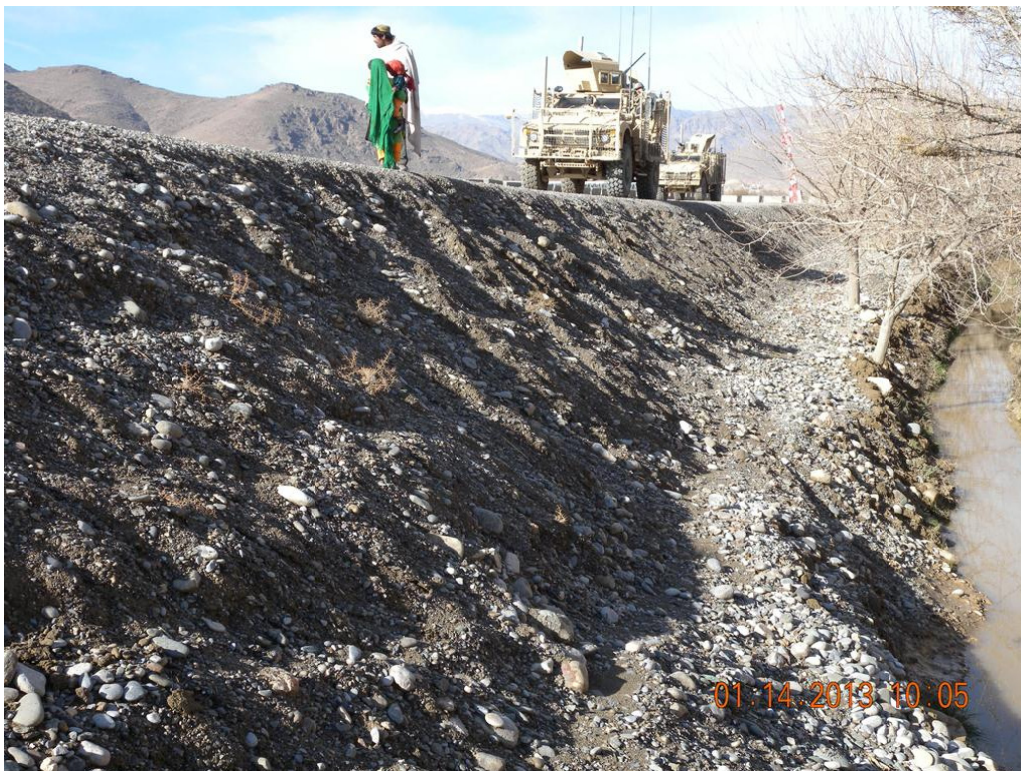
**Figure 34: View of the roadway east side slope from Station 0+440 to 0+540 km presents erosion due to rainfall**

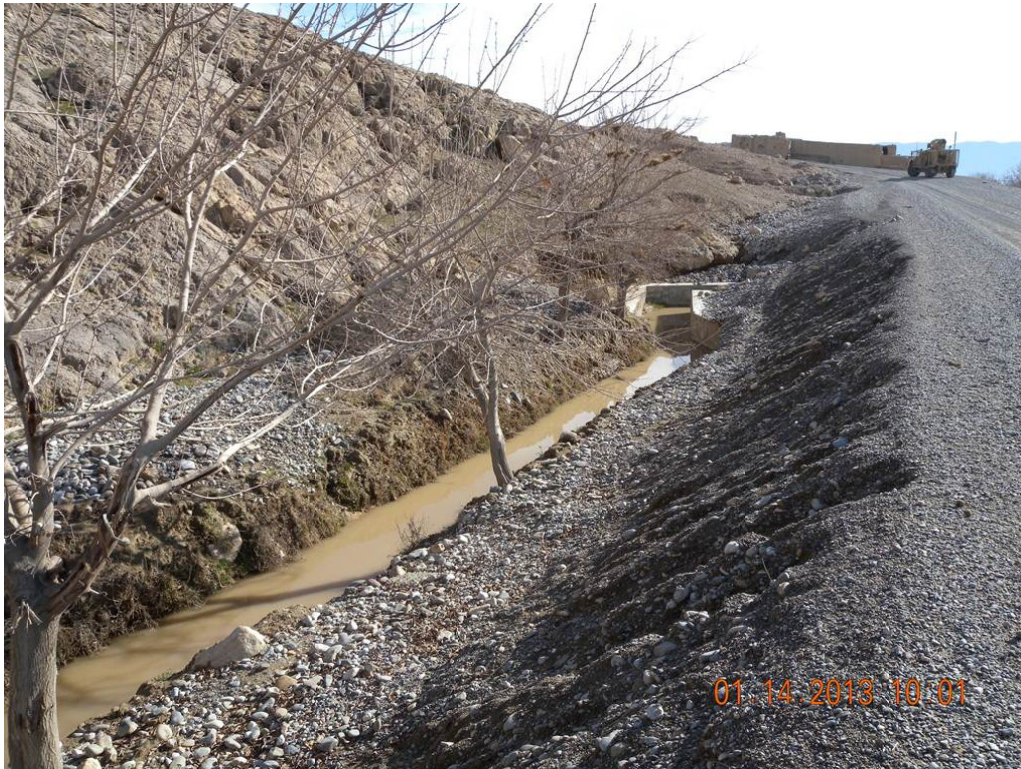
**Figure 35: View of the east side slope of the roadway from Station 0+440 to 0+540 km presents erosion due to rainfall and lack of drainage**

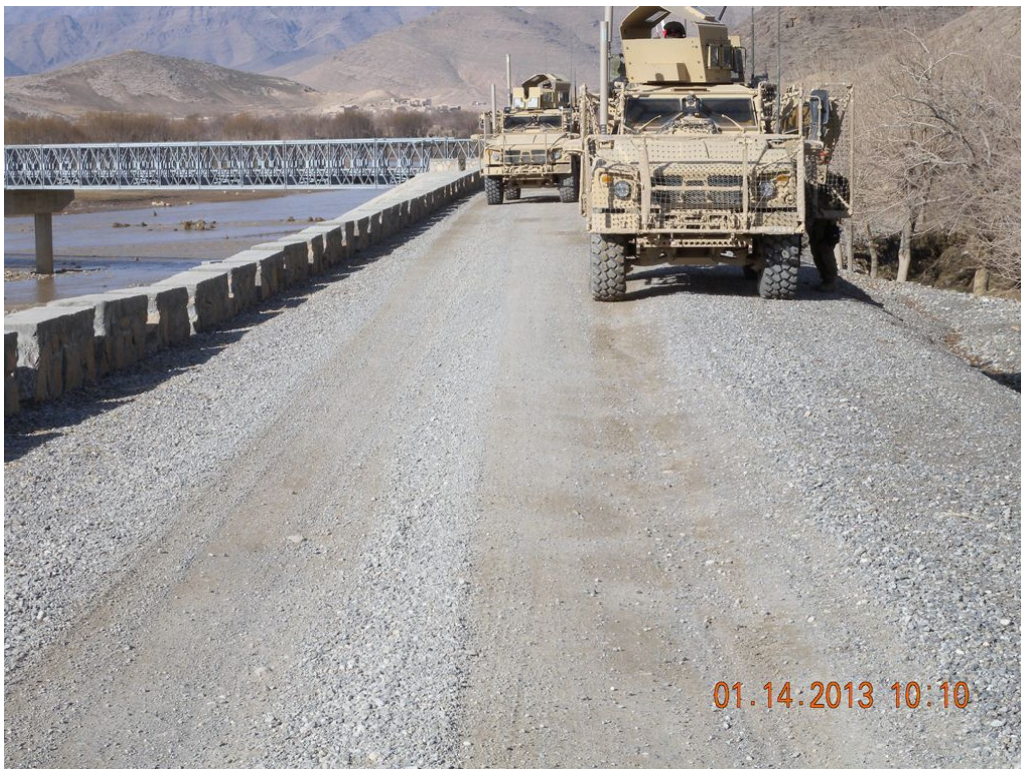
**Figure 36: View of roadway's base course that presents minor rutting from Station 0+470 to 0+520 km**

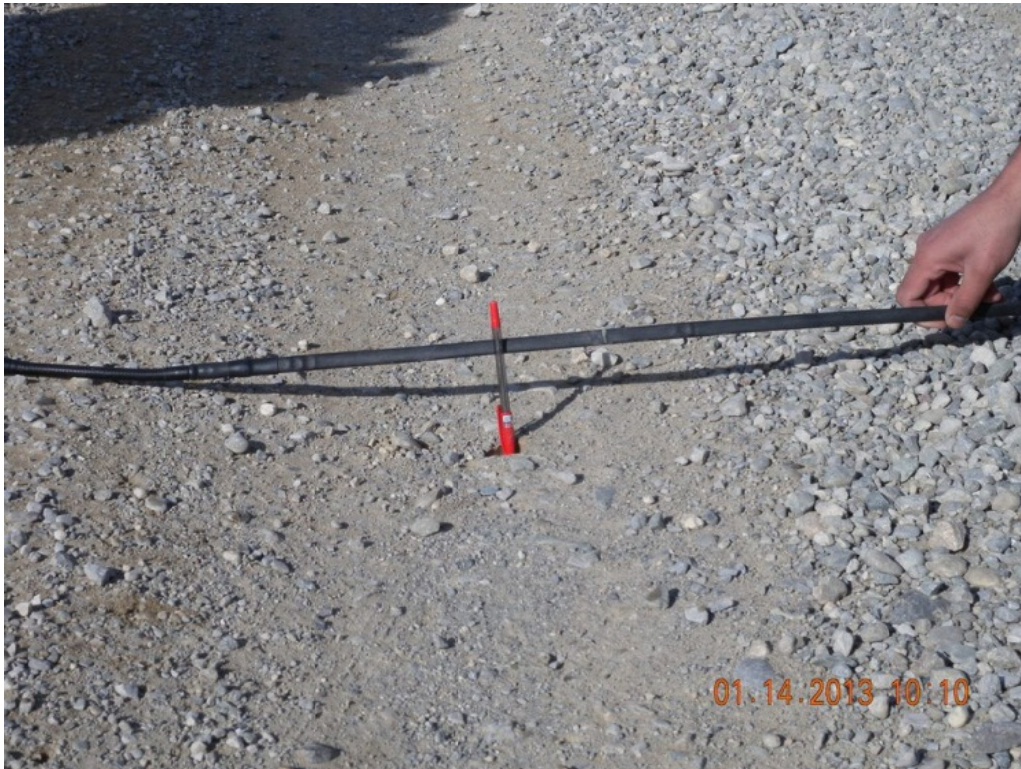
**Figure 37: View roadway's base course presents severe rutting from Station 0+520 to 0+580 km**

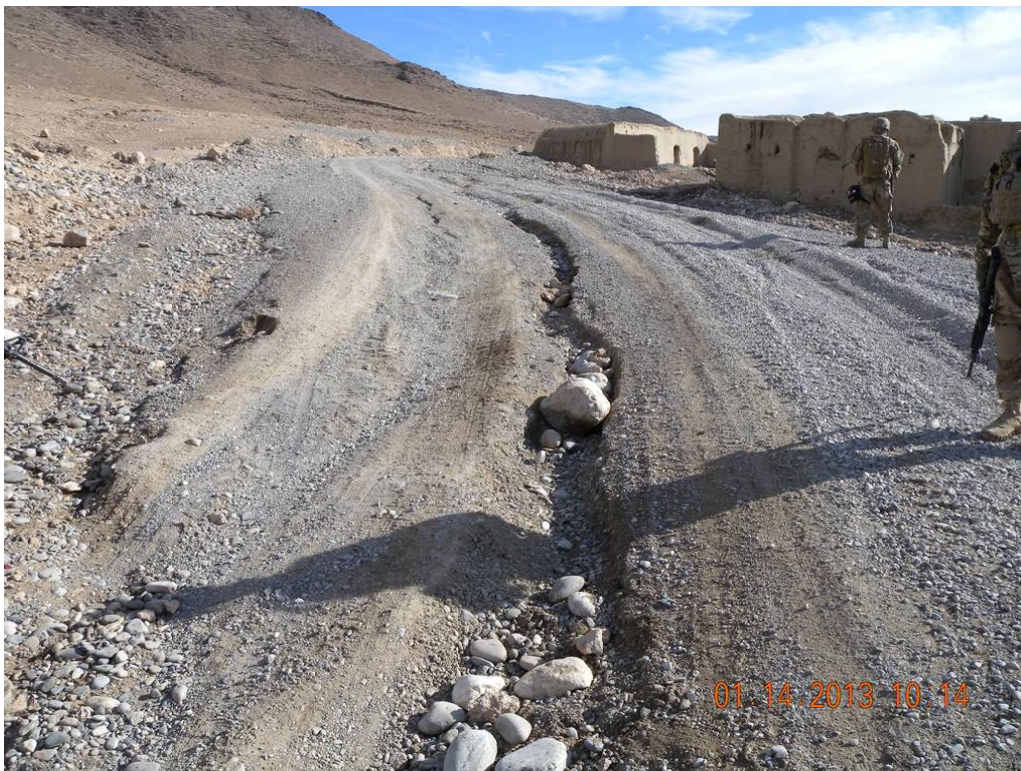
**Figure 38: View of the roadway base course that is washed out due to lack of drainage from Station 0+580 to 0+620 km**
